The Command System Malfunction of the *Telstar* Satellite

By J. S. MAYO, H. MANN, F. J. WITT, D. S. PECK,
H. K. GUMMEL and W. L. BROWN

Loss of the command function of the Telstar satellite first occurred on November 24, 1962. There had been earlier indications of degraded performance. Facts are presented which led to the conclusion that the malfunction of the command system was due to surface damage to certain transistors in the redundant command decoders by the enhanced radiation in the inner Van Allen belt.

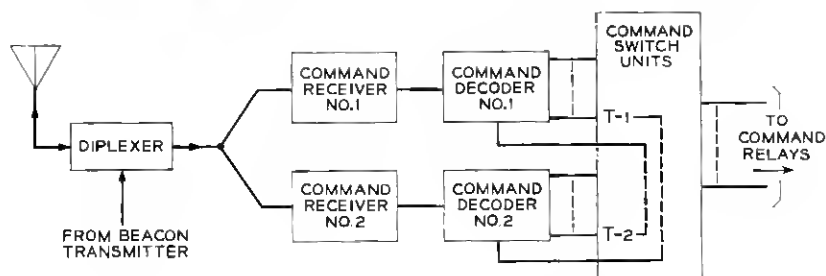
Fig. 1 — Block diagram of command system.

There are two virtually identical command decoders in the command system. Each is driven by one of the two command receivers and each drives a command switch unit, as shown in Fig. 1. Each command relay is normally driven by both command switch units in parallel; the design is such that a pulse from either or both command switch units is sufficient to operate a relay. Thus, redundancy exists between the input to the command receivers and the output of the command switch units.

Failure to respond to the T-2 command is not conclusive evidence that decoder 2 has failed. The same symptom could result from failure of command receiver 2, T-2 relay, or T-2 relay-state telemetry channel

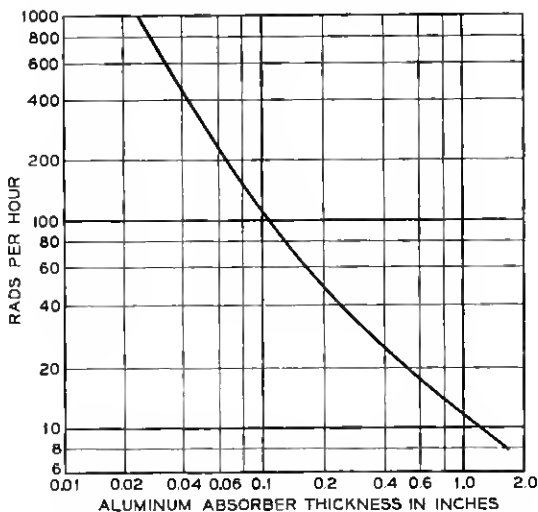
Fig. 2—The radiation due to high-energy protons in the peak of the inner Van Allen belt.

The estimated upper limit of the radiation dose contributed by energetic protons in the region of highest intensity is illustrated in Fig. 2 as a function of aluminum absorber thickness. The radiation dose rate is shown under the assumption of uniform shielding and exposure to a uniform omnidirectional proton flux. For the decoders which are very close to the surface of the electronics canister, the minimum shield thickness is only about 0.1 inch of aluminum, but the solid angle for acceptance of particles through this thickness is between $\frac{1}{4}$ and $\frac{1}{2}$ of the total 4π solid angle. The curve applied to this case gives an orbital average of between 5 and 10 rads per hour. The proton exposure of the satellite has been quite close to the pre-flight estimate.

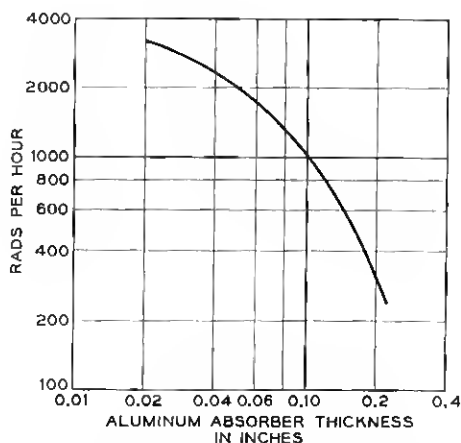
Fig. 3 — The average radiation due to high-energy electrons in the Telstar orbit.

The omnidirectional electron flux averaged over the first four months of the Telstar satellite's orbit is about 10^8 electrons/cm² sec. The radiation dose rate for electrons with this flux and the above spectrum is shown as a function of shield thickness in Fig. 3. The curve represents the radiation in the Telstar canister for shielding thicknesses small compared to that in the middle of the canister.* For transistors in the

decoder the dose rate due to electrons is approximately 10^3 rads/hour. The estimated dose rate due to protons is only 5 to 10 rads/hour. Hence the components in the Telstar command decoder have been exposed to approximately 100 times the anticipated radiation intensity, and the major contribution is not from protons but from high-energy electrons. It is believed that the peak radiation intensity could be as high as 10^4 rads/hour. The bremsstrahlung is insignificant in comparison with the direct electron effects.
